Manhole Inspection Summary

Manhole # S49CC_P01MH

Record Plat: **49CC** Node: **P01** Status: **New Manhole (Not in GIS)** Insp Date: **2/25/08 12:00 AM**

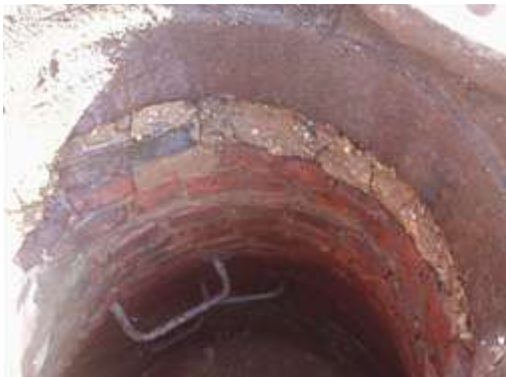
Defect 2

☒ **Leaks**

frame leaks

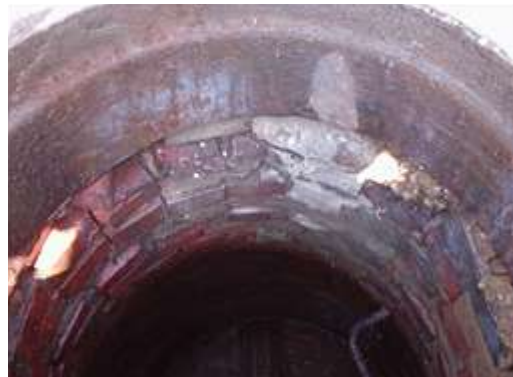
Defect 1

Condition: ☐ Sound ☐ Cracked ☐ Root Intrusion ☒ **Loose Brick** ☒ **Deteriorated**

Infiltration: ☐ None ☒ **Joint** ☐ Cracks ☐ Mortar ☐ Roots ☐ Wall

loose bricks

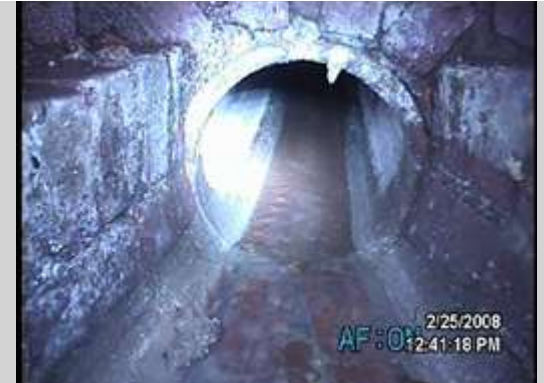
12 O'Clock Outflow

Pipe Height: **8.4** (in.) Rod and Bar (Angled)
Pipe Material: **Clay** ☐ Pipe Lined
Invert Depth: **8.95** (ft.) Flow Characteristics: **Slow**
Deposits: ☒ None ☐ Mud ☐ Sludge ☐ Debris ☐ Grease
Silt Depth: (in.) Deposits Extent:
Infiltration: **None** Pipe Seal Cond: **Sound**

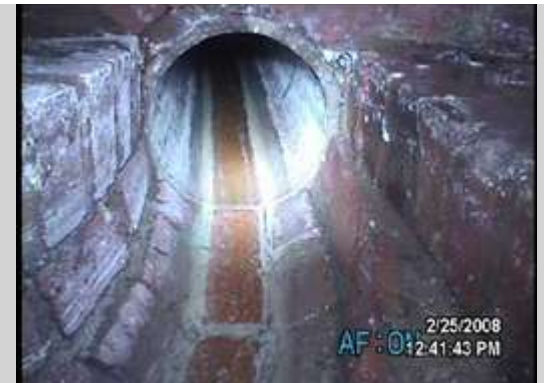
3 O'Clock Inflow

Pipe Height: **8.4** (in.) Rod and Bar (Angled)
Pipe Material: **Clay** ☐ Pipe Lined
Invert Depth: **8.90** (ft.) Flow Characteristics: **Slow**
Deposits: ☒ None ☐ Mud ☐ Sludge ☐ Debris ☐ Grease
Silt Depth: (in.) Deposits Extent:
Infiltration: **None** Pipe Seal Cond: **Sound**

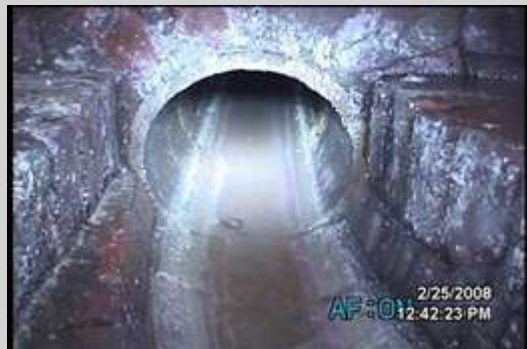
9 O'Clock Inflow

Infiltration: **None** Pipe Seal Cond: **Sound**
